**PHASE I
ENVIRONMENTAL SITE ASSESSMENT
HEARST RANCH FEE TITLE PROPERTY
SAN LUIS OBISPO COUNTY, CALIFORNIA**

SEPTEMBER 11, 2003

PHASE I ENVIRONMENTAL SITE ASSESSMENT
HEARST RANCH FEE TITLE PROPERTY
SAN LUIS COUNTY, CALIFORNIA

Robison Engineering Company
Job No. 1-04-21.001

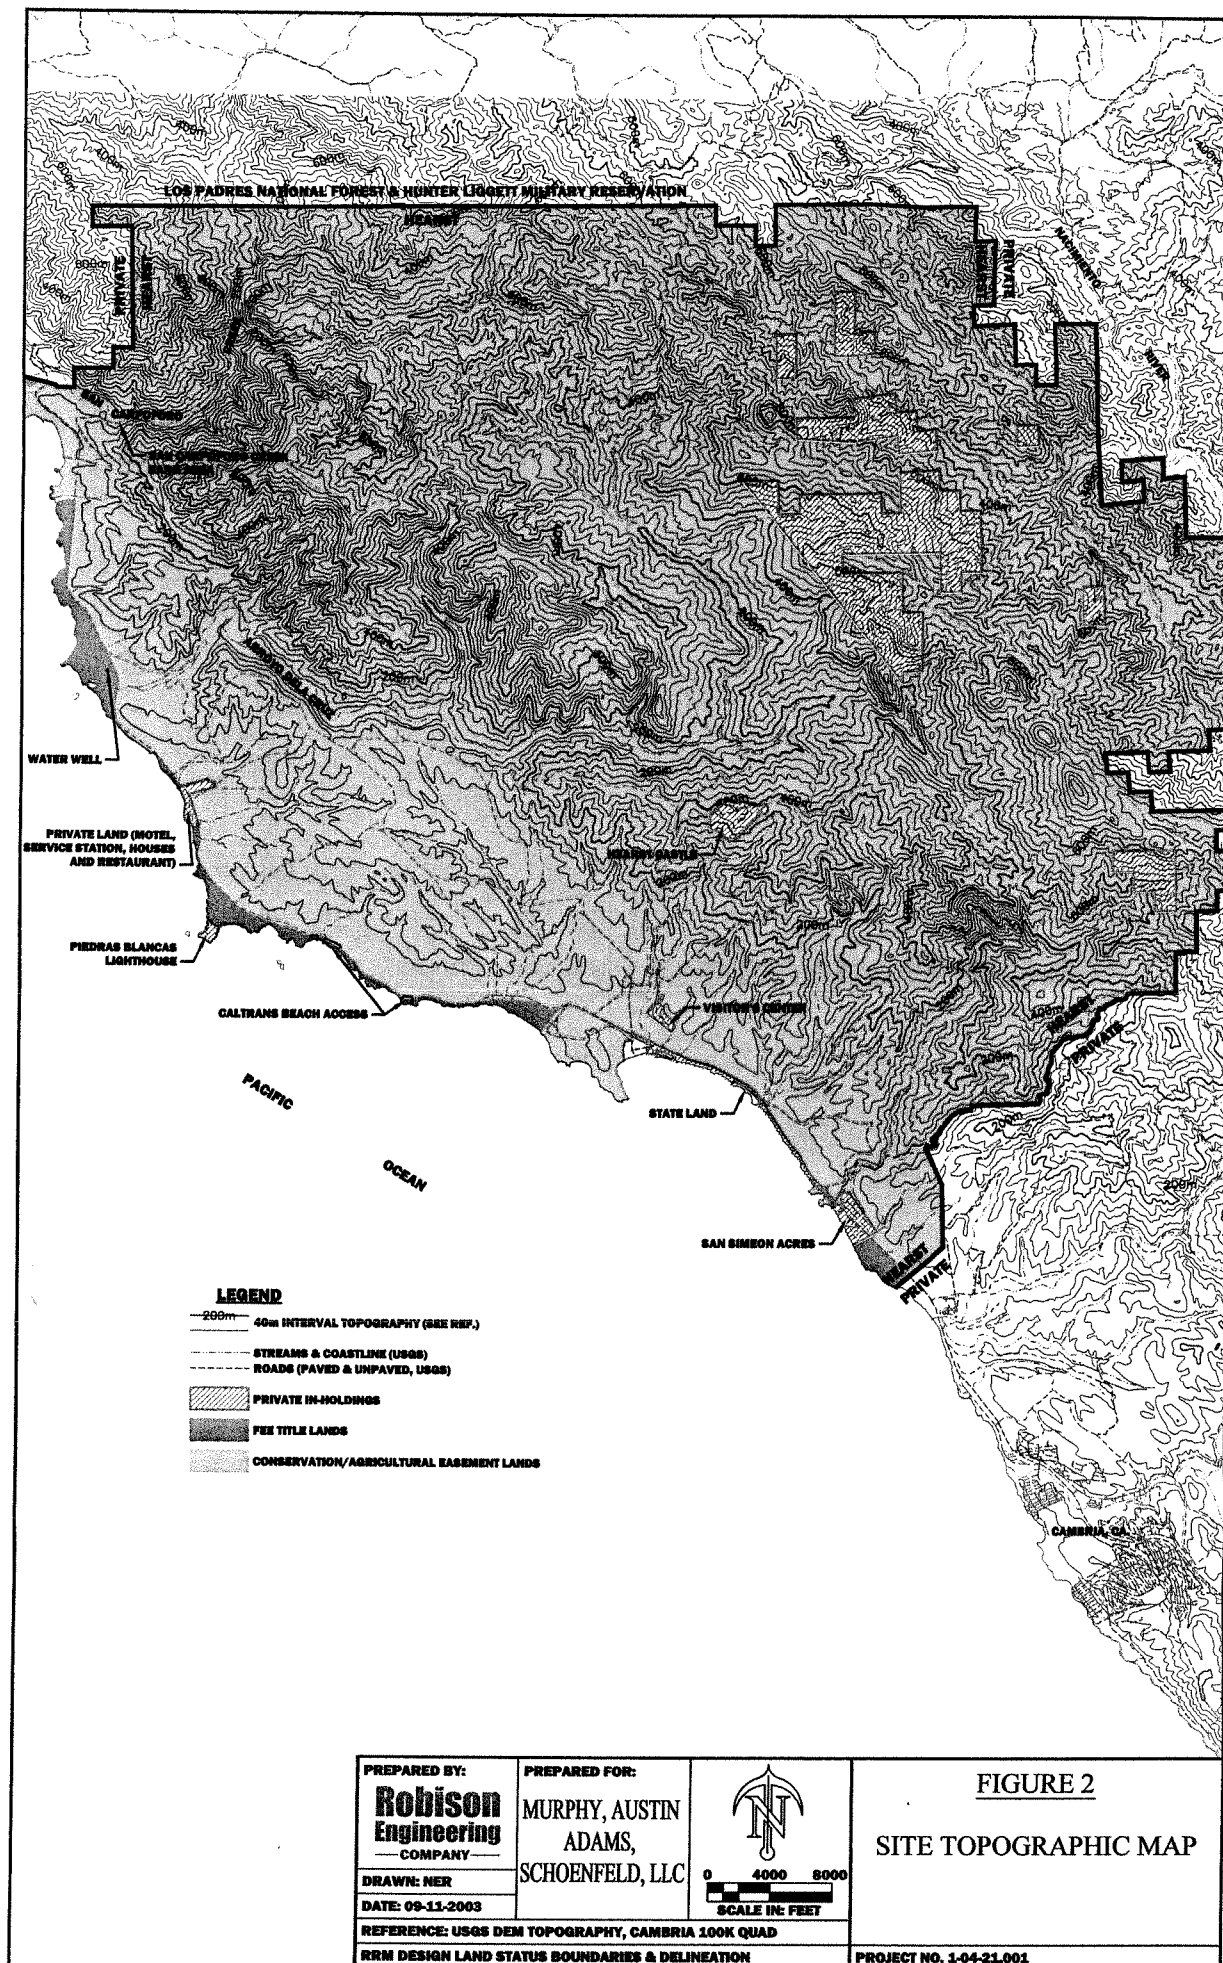
The property is undeveloped ranch land used primarily for raising cattle. The following Figure 2 shows the location of the subject property in relation to the Hearst Ranch and other adjacent properties.

San Simeon Acres is a tourist community consisting of several motels and restaurants, convenience stores, a liquor store, and houses and apartments. There is no gasoline service station in San Simeon Acres. The State of California owns the Hearst State Park on San Simeon Bay and beach-lands to the southeast of the State Park. The United States owns the Piedras Blancas Lighthouse and surrounding point. The U. S. Bureau of Land Management administers this land. The parcel north of the Piedras Blancas Lighthouse contains a motel, restaurant, gasoline service station, and several houses. The location of these adjacent properties is shown on Figure 2.

The Hearst Ranch Fee Title Property has been used exclusively for raising cattle. No buildings or other structures, except for a well (see figure 2) have been constructed on the subject property.

Multiple water wells are present on the Hearst Ranch for providing potable and livestock water. One such well is located on the Hearst Ranch Fee Title Property (see Figure 2). Groundwater is primarily present in the unconsolidated soils along the major drainages (San Carpoforo Creek and Arroyo De La Cruz). The groundwater is present at depths from 9 to 45 feet and the quality is reported as slightly hard but otherwise good. ⁽⁴⁾ The general groundwater flow direction on the Hearst Ranch Fee Title Property is to the west-southwest, into the Pacific Ocean.
